Manhole Inspection Summary

Manhole # S21AA_051MH

Location Address: **1800 ALLEY-MOSHER-LAFEYETTE** Cross Street: **MCKEAN-FULTON**

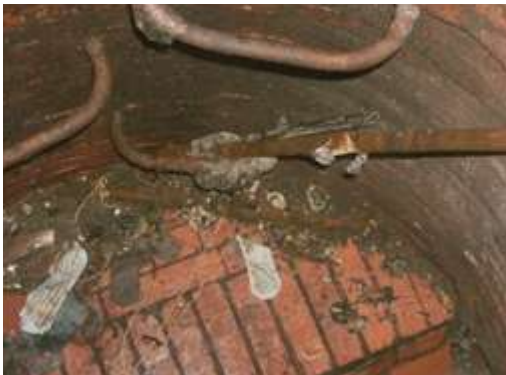
Defect 2

Steps Count: **4** Missing: **0** ☒ **Corroded**

Surcharge ☒ **Evidence Of Surcharge** Depth: **2** (ft.) ☐ Active Surcharge Present

SURCHARGE EVIDENCE ON
CORRODED STEP

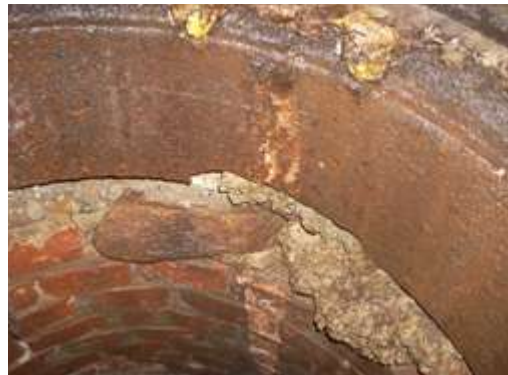
Defect 1

Chimney / Frame Adjustment ☒ Exists Material: **Concrete and Stone** ☐ Parged Height: **3** (in.)
Condition: ☐ Sound ☐ Cracked ☐ Root Intrusion ☐ Loose Brick ☒ **Deteriorated**
Infiltration: ☒ None ☐ Joint ☐ Cracks ☐ Mortar ☐ Roots ☐ Wall

CHIMNEY DETERIORATION

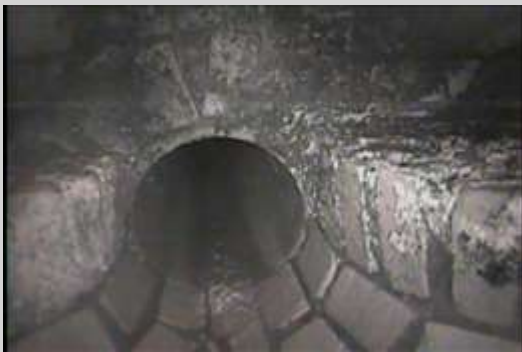
12 O'Clock Outflow

8 in. Circular Gravity Sewer
Pipe Out @ 12 O'Clock

Pipe Height: **8.4** (in.) Rod and Bar (Angled)
Pipe Material: **Clay** ☐ Pipe Lined
Invert Depth: **8.15** (ft.) Flow Characteristics: **Slow**
Deposits: ☒ None ☐ Mud ☐ Sludge ☐ Debris ☐ Grease
Silt Depth: (in.) Deposits Extent:
Infiltration: **None** Pipe Seal Cond: **Sound**

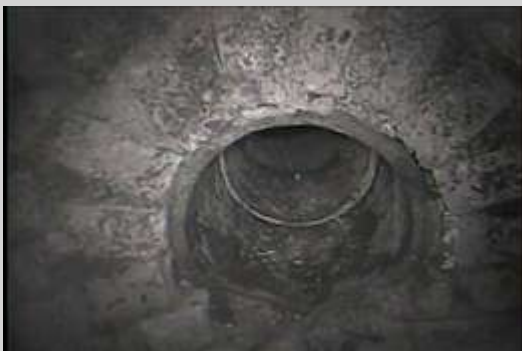
3 O'Clock Inflow

8 in. Circular Gravity Sewer
Pipe In @ 3 O'Clock

Pipe Height: **8.4** (in.) Rod and Bar (Angled)
Pipe Material: **Clay** ☐ Pipe Lined
Invert Depth: **6.24** (ft.) Flow Characteristics: **Fast**
Deposits: ☒ None ☐ Mud ☐ Sludge ☐ Debris ☐ Grease
Silt Depth: (in.) Deposits Extent:
Infiltration: **None** Pipe Seal Cond: **Sound**

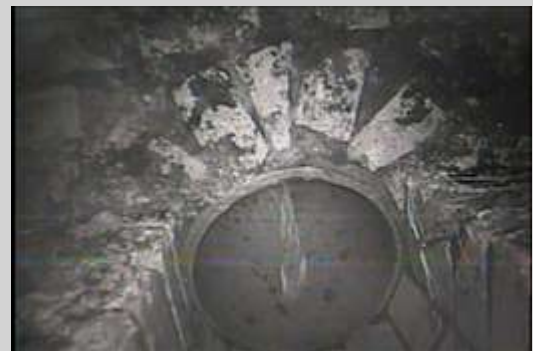
Drop In @ 3 O'Clock

Drop: **Outside** Rod and Bar
Angled: **Yes** Reading: **7.02** (ft.)
Inv Depth: **8.02** (ft.)
Drop Condition: **Open**

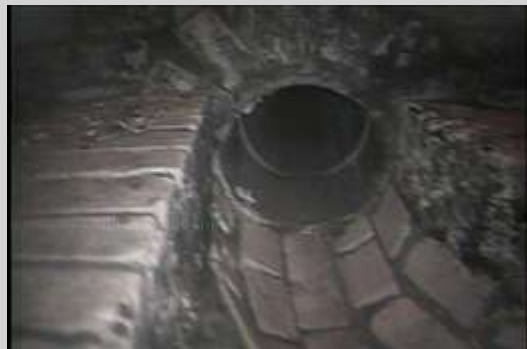
9 O'Clock Inflow

8 in. Circular Gravity Sewer

Pipe In @ 9 O'Clock

Pipe Height: **8.4** (in.) Rod and Bar (Angled)

Pipe Material: **Clay** ☐ Pipe Lined

Invert Depth: **7.81** (ft.) Flow Characteristics: **Slow**

Infiltration: **None** Pipe Seal Cond: **Sound**
